# **INDOOR AIR QUALITY ASSESSMENT**

**Veterans Memorial High School  
485 Lowell Street  
Peabody, Massachusetts**

Prepared by:  
Massachusetts Department of Public Health  
Bureau of Environmental Health Assessment  
April, 2002

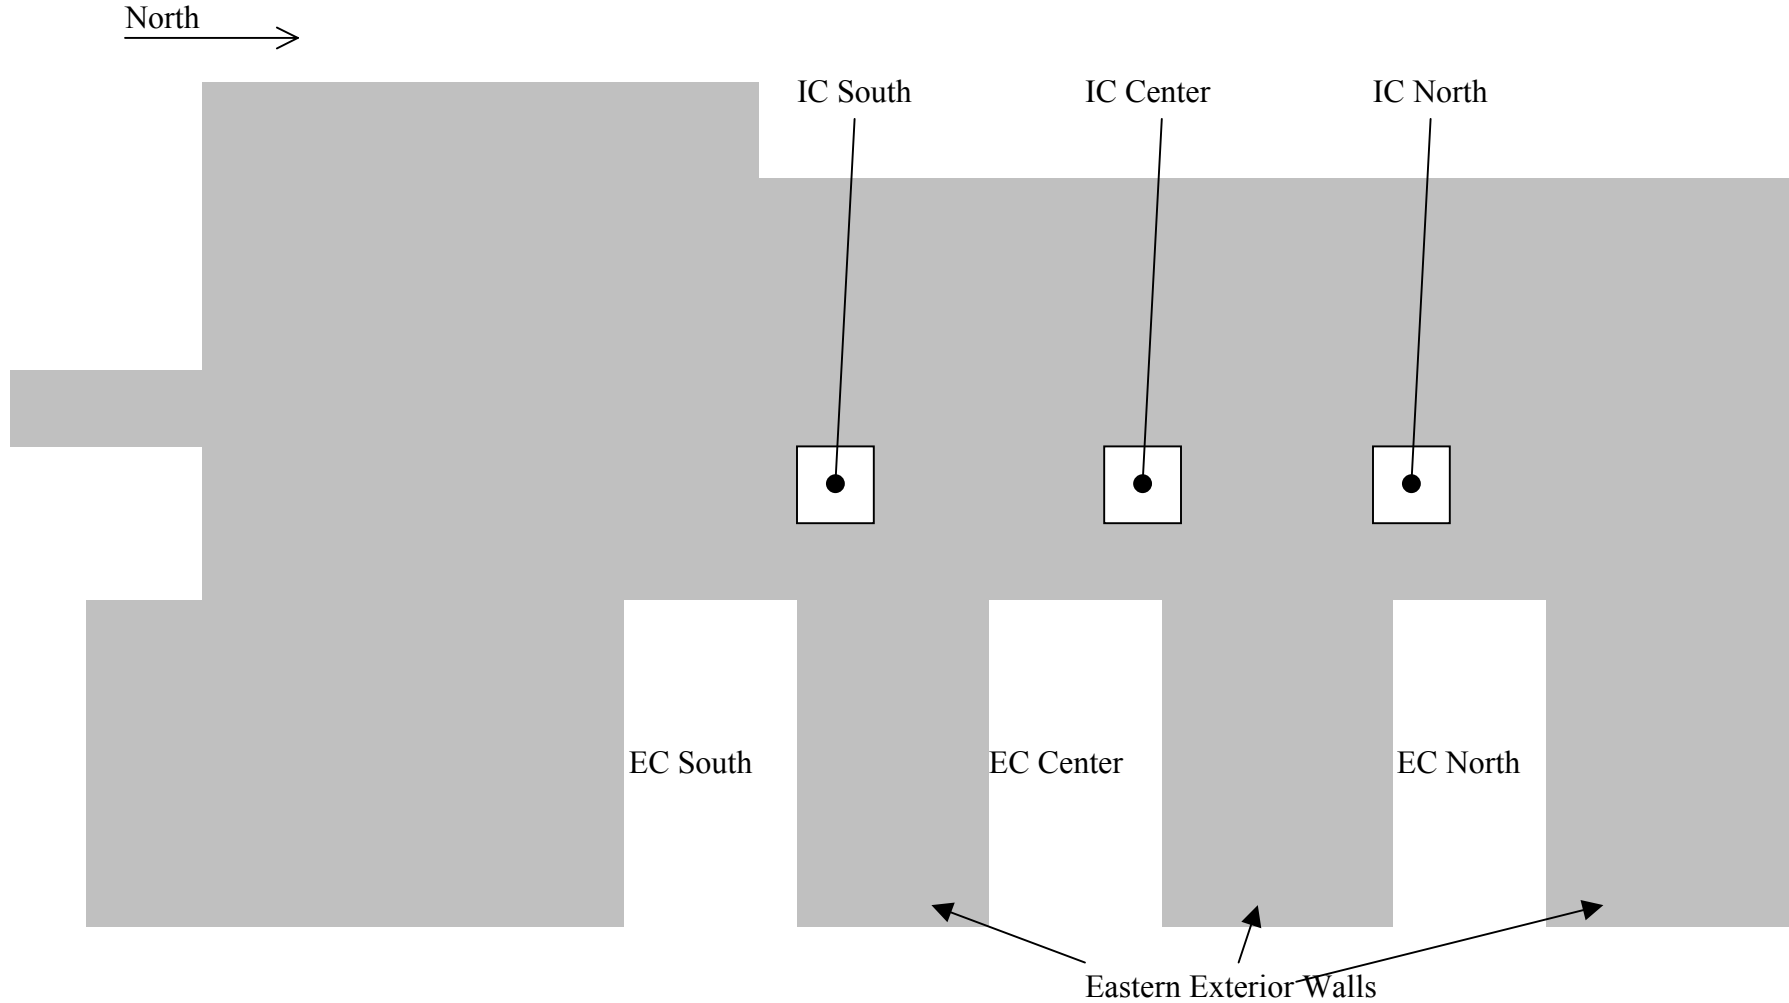
**Figure 1**  
**General Configuration of PVNHS Depicting Location of Courtyards**

PVMHS is a three-level complex built in 1973. The building is configured with three interior courtyards (ICs) located in the center of the building (see Figure 1). Three open courtyards [exterior courtyards (ECs)] exist on the eastern side of the building. The first level is primarily made up of special-use rooms/areas such as the cafeteria and kitchen, industrial arts, the field house, cosmetology program, the auditorium and office space. The second level consists of general classrooms, science rooms, laboratories, main administrative offices and special purpose rooms (e.g. band, art and food preparation classrooms). The third level is predominantly comprised of general-use classrooms. The windows in the building are of a sliding design, which are openable in

Of note are the exterior walls that form the ECs on the eastern side of the building (see Figure 1). No weep holes were identified in any of the exterior brick wall system that forms these courtyards in a manner that would be consistent with other areas of the PVMHS. Either weep holes were not installed or are buried below grade. The steel exterior wall system of the courtyards shows signs of significant water exposure, which would direct moisture into the walls of the courtyard.
